Nauru Priority Water Sector Development and Funding Needs Report

DRAFT REPORT

DOCUMENT NAME Technical Review of Water Security and Climate Change Priority Activities for Nauru
 Priority Water Sector Development and Funding Needs Report

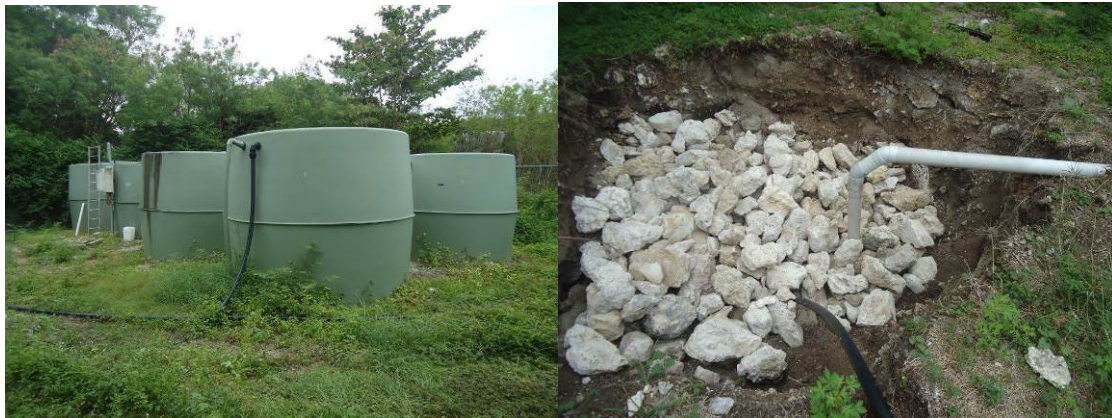
Figure 6. Sewage treatment Plant at Nauru Primary School with Effluent Dispersal Pit

The existing “green” sewage treatment plant located adjacent to the Nauru Primary School has not been operating correctly for some time. The treatment plant was constructed as part of the original refugee centre on the island and originally operated as a biological filter plant.

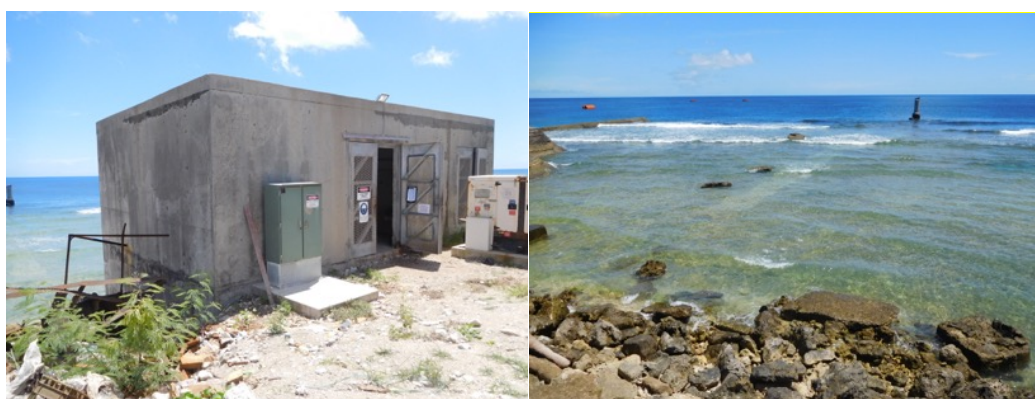
Inspection of the seawater intake on 19th May 2017 found that there was significant damage to concrete of the structure and the condition had worsened significantly since 2015. There was both internal and external damage with the internal damage appearing to be worse than the external damage.

Figure 8. Existing Seawater Intake Structure and Inlet Pipeline to Marker at Edge of Reef

A detailed inspection by a suitably qualified structural engineer is required to ascertain the extent of the damage and recommend appropriate remedial work. As such an amount has been included in the scope of works to undertake a structural inspection and facilitate repairs to the structure. It is possible that CIE may be able to procure funding from the Australian government for these works as they are a shared facility for both the RPC centres and the Nauruan population.

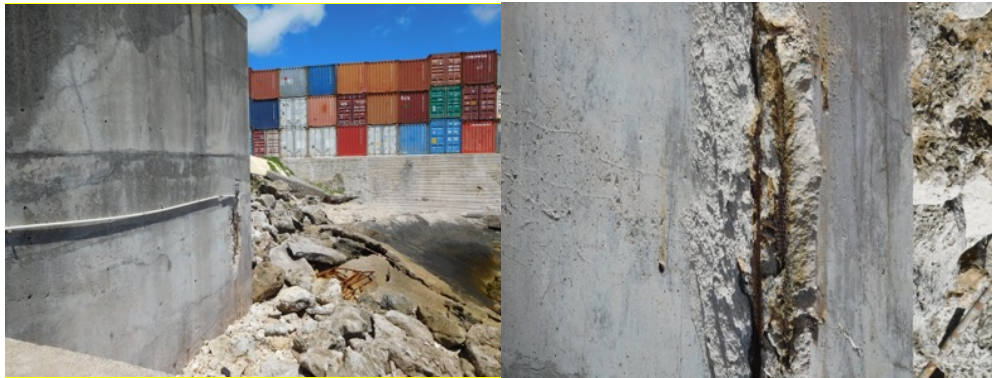
Figure 9. External Concrete Damage to Structure with Steel Reinforcement Now Exposed

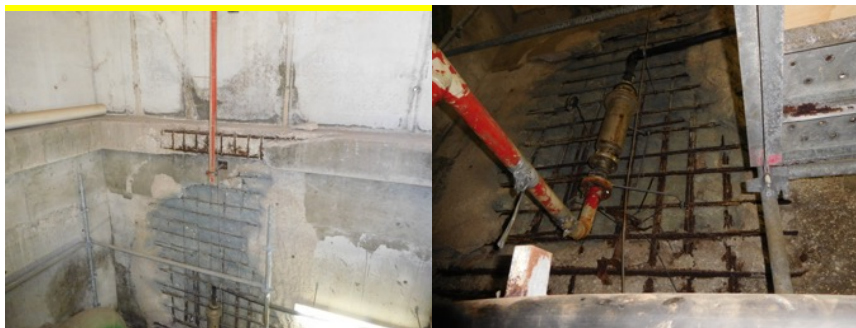
Figure 10. Concrete spalling and Steel Reinforcement Exposed on Internal Side Wall

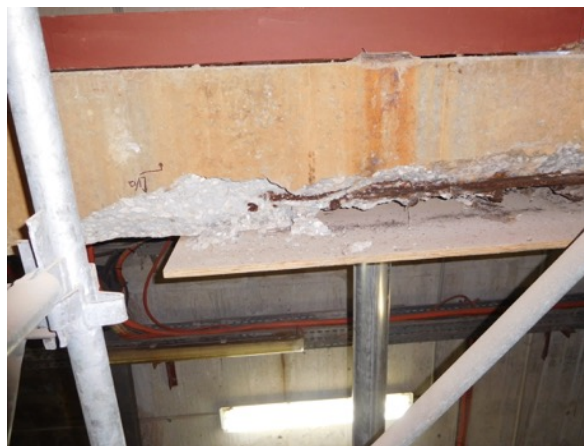
Figure 11. Concrete damage and exposed Steel Reinforcement on Upper Floor Slab

It was noted that the pump station building does not appear to be leaking at all and that the concrete issues may be localised to the upper half of the building. It is possible that poor grade concrete and insufficient cover to steel was used on the upper portion of the structure and that the lower section of the structure was well-constructed.

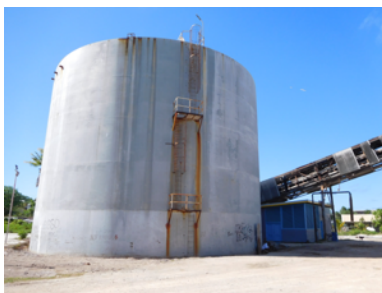
Tank B13 was empty and was undergoing a condition assessment – a report will be produced (by others) which will outline proposed works. It was noted that although the roof of the tank showed severe corrosion, the side walls of the tank and floor were in relatively good condition and the tank should be able to offer long term service if a liner were installed (a detailed report will be produced to confirm these suggestions).

Figure 13. Tank 'B13' remaining – tank 'B10' demolished (by May 2017)

1. Cost to upgrade tank B13 – this will be based on the assumption that it is economically viable to upgrade based on the condition assessment report (not yet available). As a minimum the roof will require replacement and it is likely that a liner would be recommended for installation within the tank.
2. Cost for new 4ML tank to provide for the tank that was intended to be funded under USAID.
3. Increased estimate for 4ML tanks in Nauru. The tender prices for the USAID funded 4ML tank at Nauru in 2016 exceeded the USAID budget and based on tender prices received, the cost estimates for constructing new 4ML tanks on the island would need to be increased for budgeting purposes. This has also been undertaken in the updated costings.

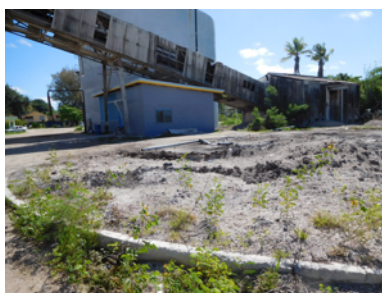
Tank B10 had been completely demolished by May 2017.

Figure 14. View showing remaining base of 'B10' and Upgraded Pump Station Building (Blue Building)

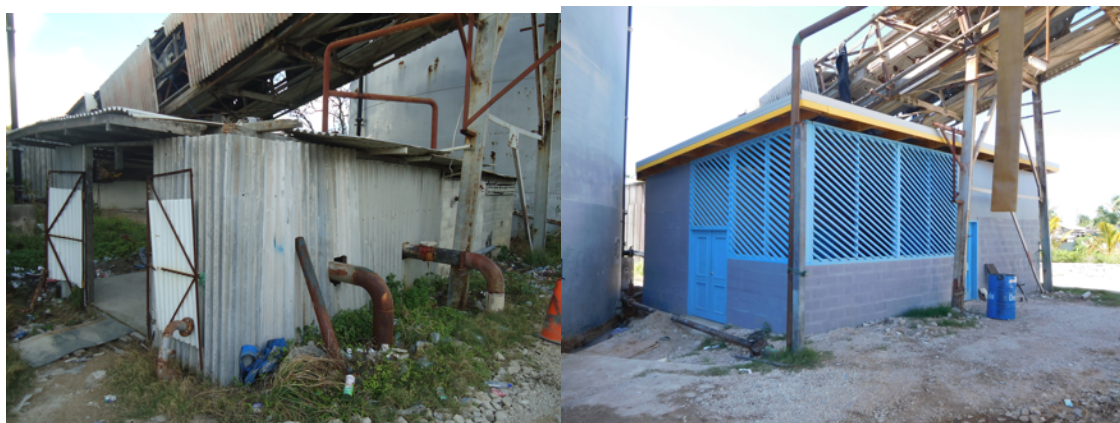
Figure 15. Pump Station Building Before (2015) and After Upgrade (May 2017)

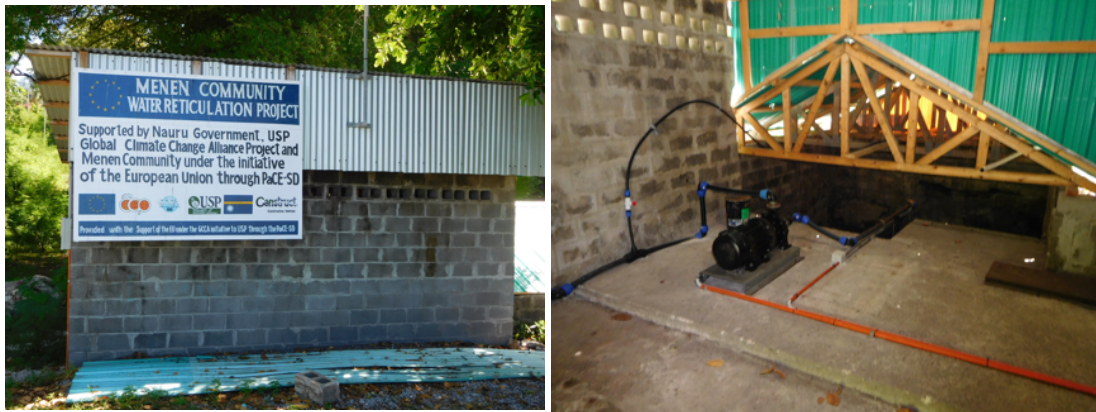
Figure 17. Pump Station for Brackish Water

It was noted that the pump station is located only some 50m from the sea which means that the water is likely to be of high salinity. Due to the health concerns raised in the Master Plan regarding the effluent discharges from the Nauru Primary School Sewage treatment plant to the Meneng groundwater, the distance between the pump station and the school is seen as positive.

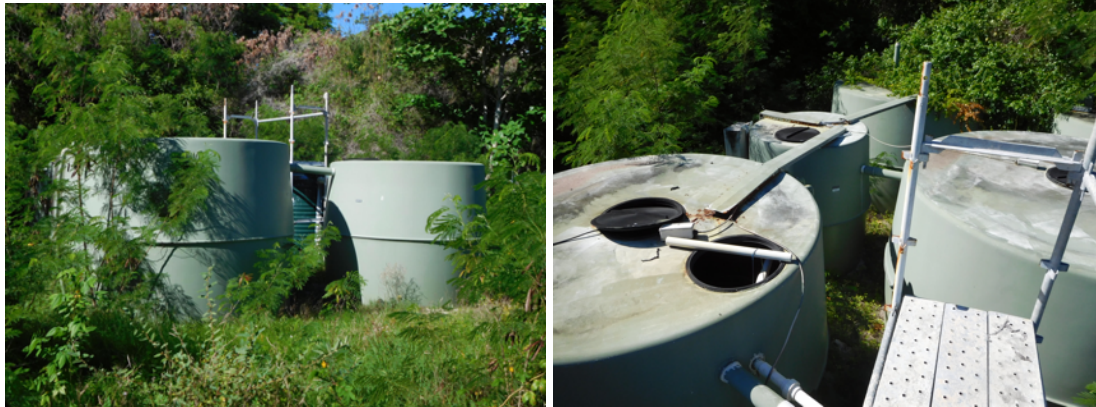
2. The original sewage “green” treatment plant is in use with a minor repair attempt having been attempted since 2015. One of the treatment tanks has been replaced and there has been an attempt to recommission electrical supply to pump(s). The final stage of the treatment facility (filters) are overgrown with vegetation and do not appear to be functional.

Figure 21. The older “Green” Sewage Treatment Plant at Nauru Primary School

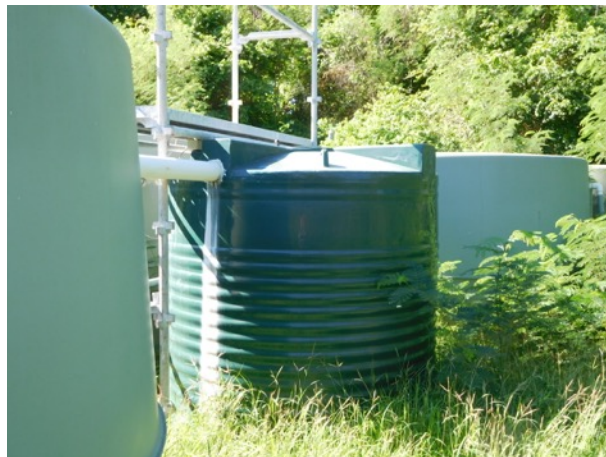
Figure 22. A replacement tank has been installed at the plant
