Survey of the Regional Distribution and Status of Asbestos-Contaminated Construction Material and Best Practice Options for its Management in Pacific Island Countries

**Report for the
Republic of Nauru**

**Prepared for the Secretariat of the Pacific Regional
Environment Programme (SPREP)**

June 2015

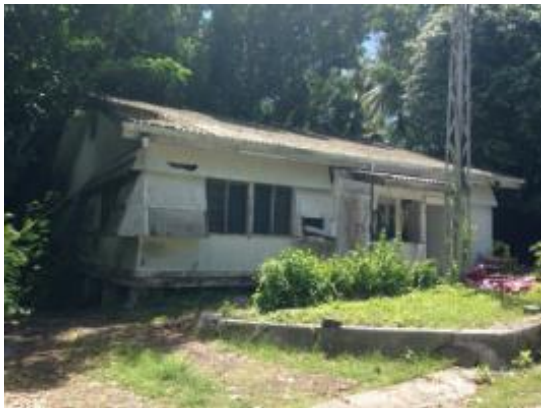
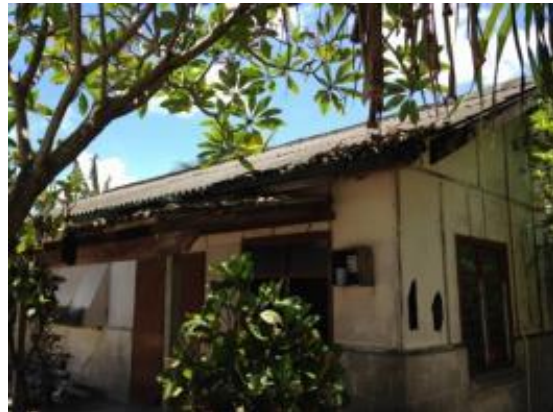
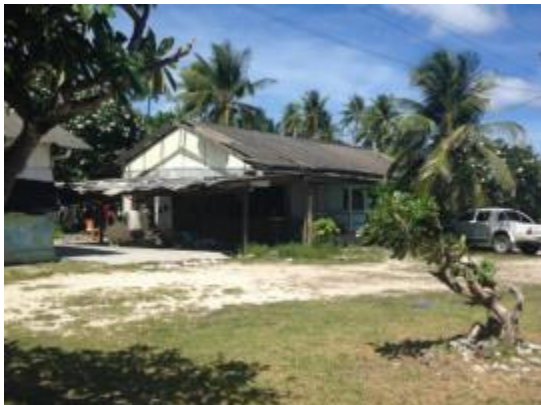
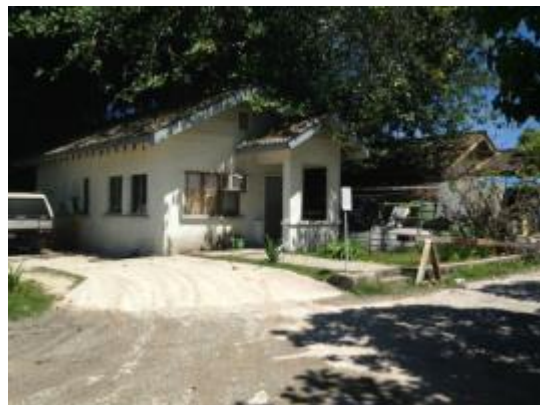
Photos 5-10 – Six Typical Houses with Asbestos Roofs and Possibly Asbestos Cladding

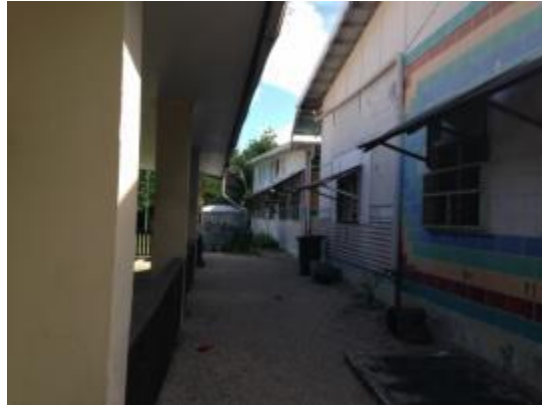
In the cases of the three infant schools shown below, only the cladding (and not all the cladding) has been confirmed as asbestos). The vinyl floors were checked at the Anetan and Nibok Schools and found to be negative for asbestos.

Photos 18-22 - Boe Infant School Asbestos Cladding

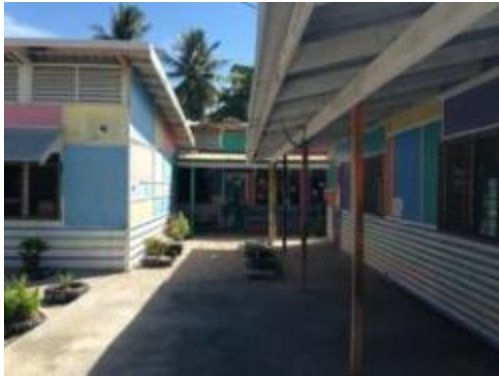
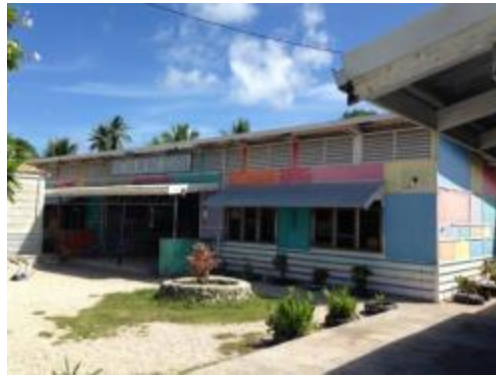
Photos 27-30 – Anetan Infant School Asbestos Cladding

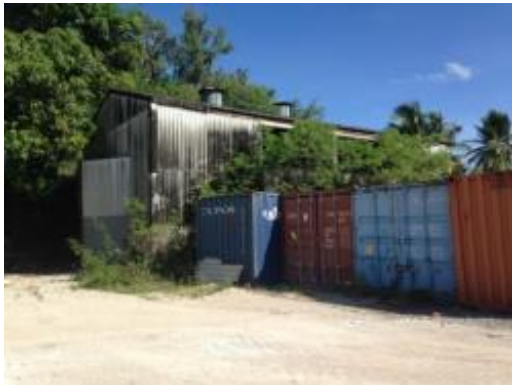
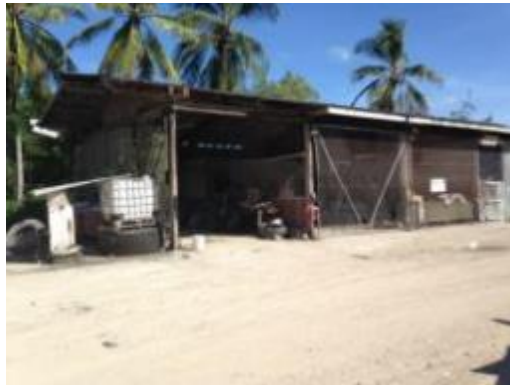
The NRC workshops and maintenance area is up on Topside and all the buildings are clustered together in one area. Most of them have asbestos cladding, much of which is deteriorating. Photos 32-39 below show the main buildings:

Photos 32-39 – Various Buildings in NRC Workshop Area with Asbestos Roofing and Cladding

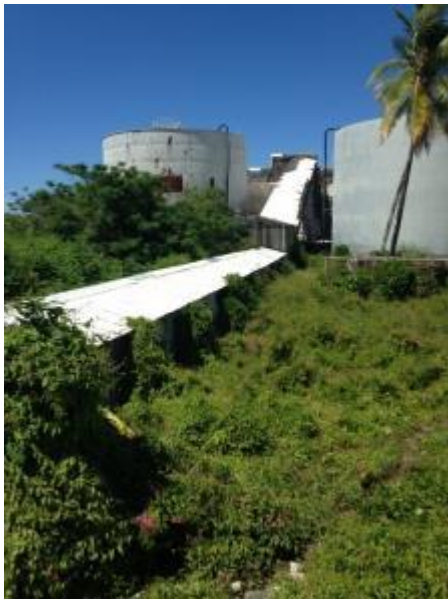
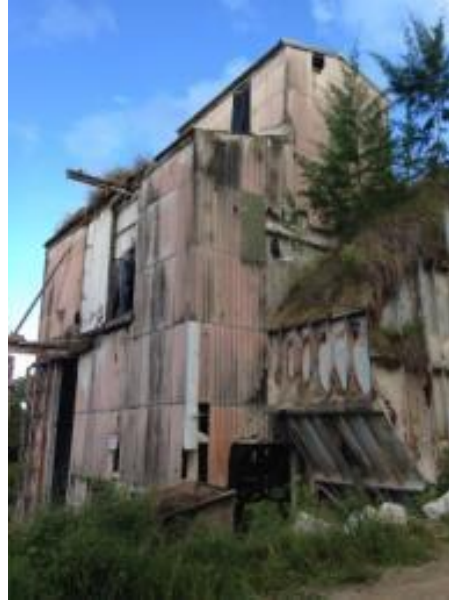
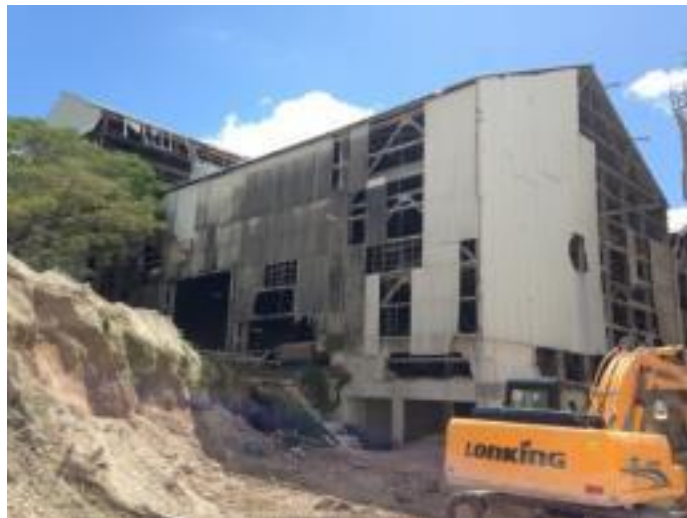
Photos 51-56 show some of the various components of the phosphate processing plant, which is still partly operational although some sections are not used now and are falling into disrepair. The first photo shows the conveyor from the processing area to the storage area.

Photos 51-56 – The Old RonPHOS Processing Area

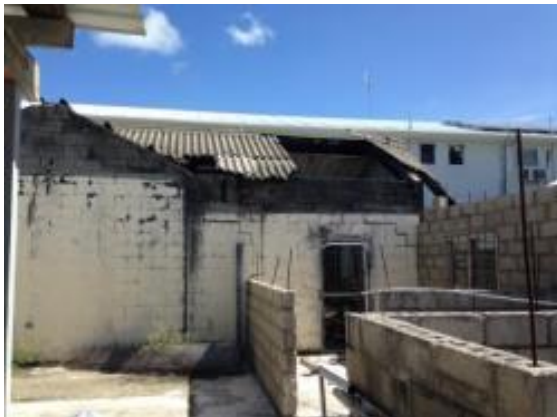
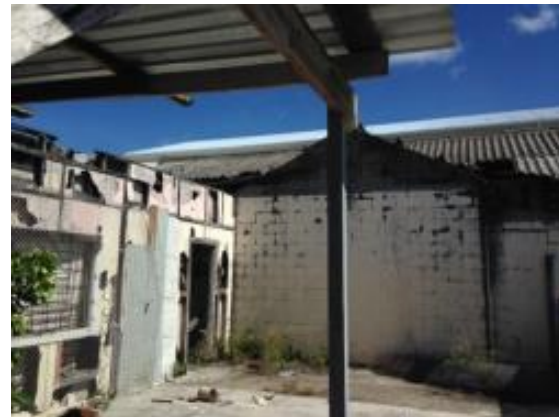
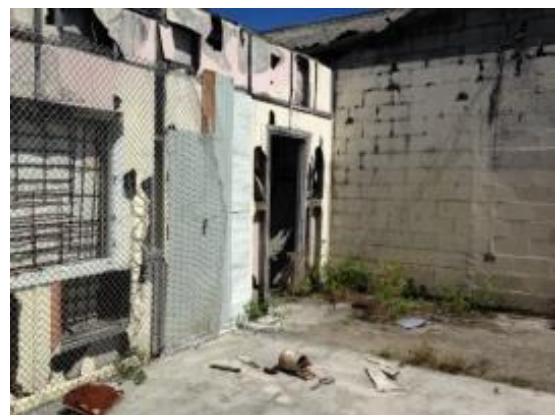
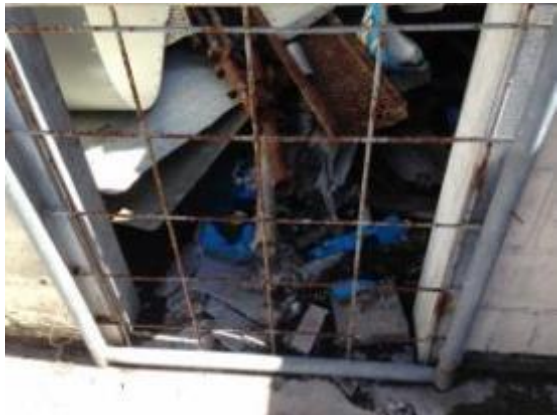
There was a fire in the combined Prison and Police Station in 2007. The Police Station was relocated but the prison remained on the same location. Some of the burnt-out buildings are still in place together with some of the old debris. They have damaged asbestos roofing and cladding – see Photos 75-78 below.

Photos 75-78 – Prison Asbestos in Burnt Area including Asbestos Debris

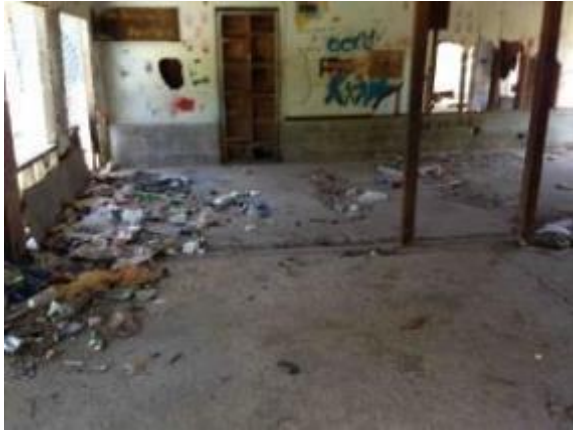
Photo 5 – Old House with Broken Asbestos

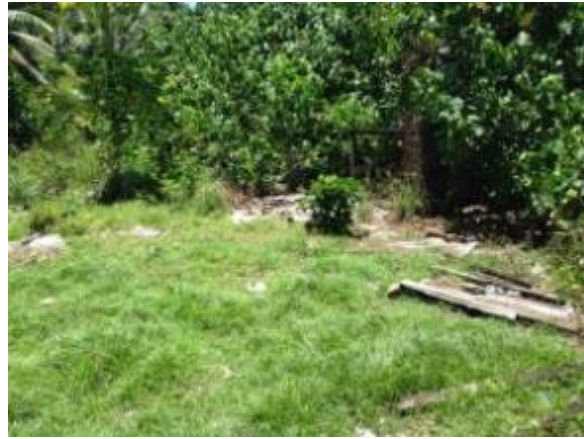
Photo 6 – Asbestos on Ground Behind House

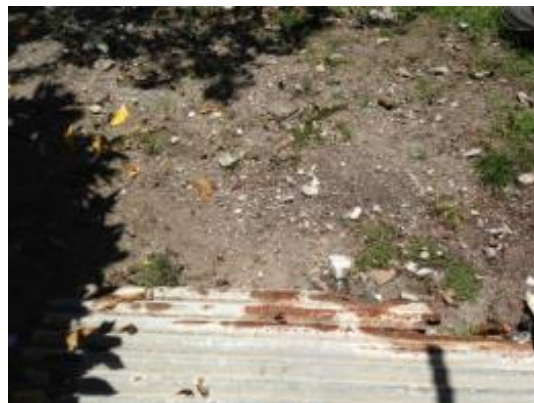
In addition asbestos debris was spread over the hospital grounds by the fire which would have generated loose asbestos fibres and small pieces of asbestos. This debris was evident on the ground even a year after the fire – see photo below:

Considering the high risk, it was decided to remove immediately the remaining part of the burnt structure and cleaning up the ground. The local company Central Meridian was commissioned to undertake the removal and clean-up work, and this work was supervised by John O’Grady from Contract Environmental Ltd.
