Nauru Priority Water Sector Development and Funding Needs Report

DRAFT REPORT

DOCUMENT NAME Technical Review of Water Security and Climate Change Priority Activities for Nauru
 Priority Water Sector Development and Funding Needs Report

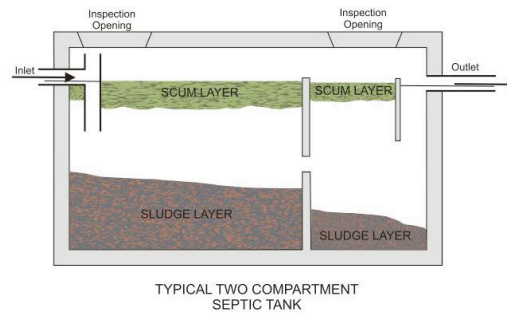
Figure 3. Typical Septic Tank

As shown in the figures above, the fully enclosed septic tank provides an improved primary treatment to the cesspit before discharging the effluent to the seepage drains in the adjacent ground. Septic tank effluent will still contain approximately 40% of the pollutants and 25% of the pathogens in the raw sewage and therefore should not be discharged close to a water source being used where human contact is likely.

It is reported that a number of septic tanks are, however, also damaged and leaking which means that they are not functioning correctly and also discharging to the adjacent soil although it is likely that the bulk of the solids are still being retained. It is well documented in the previous studies that the widespread use of cesspits and poorly functioning septic tanks had led to severe contamination of groundwater. Due to the continued use of groundwater for toilet flushing plus washing, laundry and in some cases drinking, this clearly poses a significant health risk.

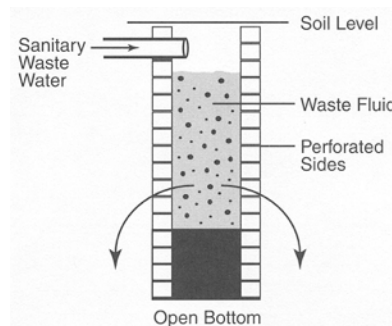
Figure 4. Typical Cesspit

The cesspits discharge raw sewage directly to the adjacent ground through the open bottom and perforated sides of the units.

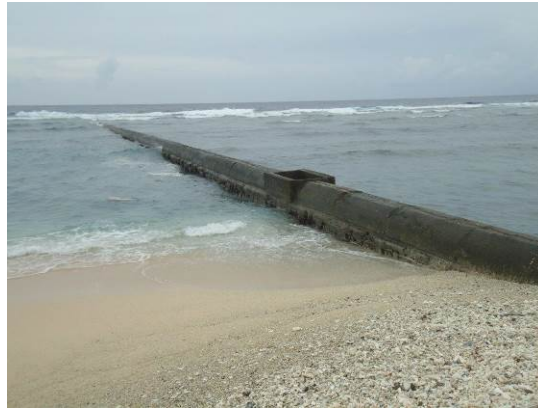
Figure 5. Sewage Ocean Outfall Structure

Until recently, when septic tanks and cesspits needed pumping out, the pumpout material was disposed of through the many ocean outfalls that exist on the island.

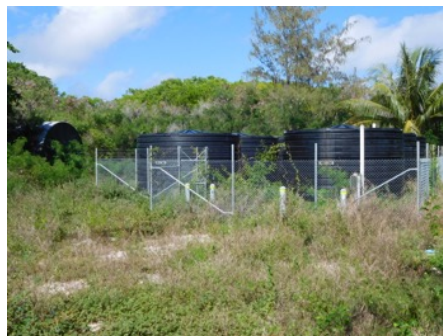
Figure 7. New Sewage Plant for New School Building at Nauru Primary School

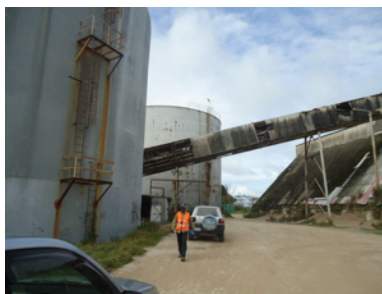
Figure 12. Tanks B'13' and 'B10' at time of Master Plan (2015)

Tank B13 was empty and was undergoing a condition assessment – a report will be produced (by others) which will outline proposed works. It was noted that although the roof of the tank showed severe corrosion, the side walls of the tank and floor were in relatively good condition and the tank should be able to offer long term service if a liner were installed (a detailed report will be produced to confirm these suggestions).

Tank B10 had been completely demolished by May 2017.

1. Cost to upgrade tank B13 – this will be based on the assumption that it is economically viable to upgrade based on the condition assessment report (not yet available). As a minimum the roof will require replacement and it is likely that a liner would be recommended for installation within the tank.
2. Cost for new 4ML tank to provide for the tank that was intended to be funded under USAID.
3. Increased estimate for 4ML tanks in Nauru. The tender prices for the USAID funded 4ML tank at Nauru in 2016 exceeded the USAID budget and based on tender prices received, the cost estimates for constructing new 4ML tanks on the island would need to be increased for budgeting purposes. This has also been undertaken in the updated costings.

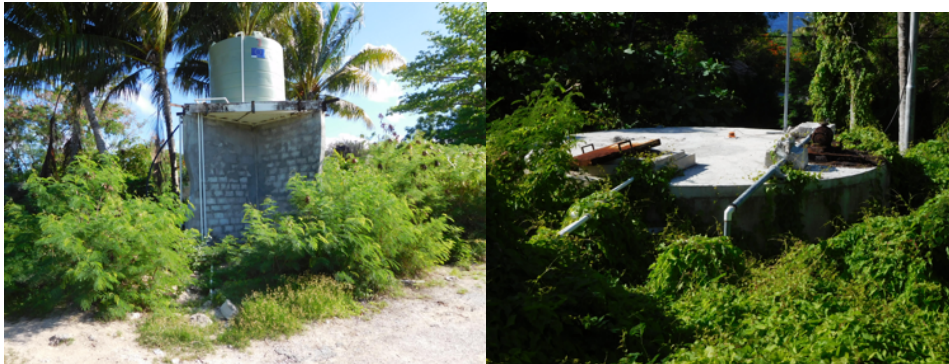
It was noted during the May 2017 site visit that the Meneng brackish water scheme had been largely completed and will provide brackish water to some 400 people in the Meneng district for toilet flushing. This scheme is therefore effective in reducing the dependence on desalination water from NUC.

Figure 16. Water Storage Tanks for the Meneng Brackish Water Scheme

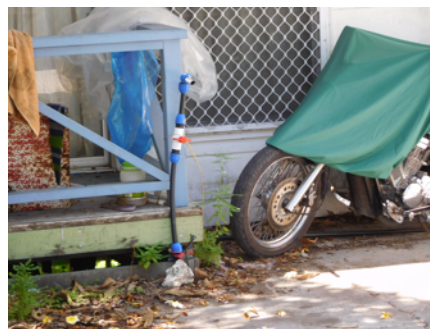
Figure 18. Typical Brackish Water Service Connection in Meneng

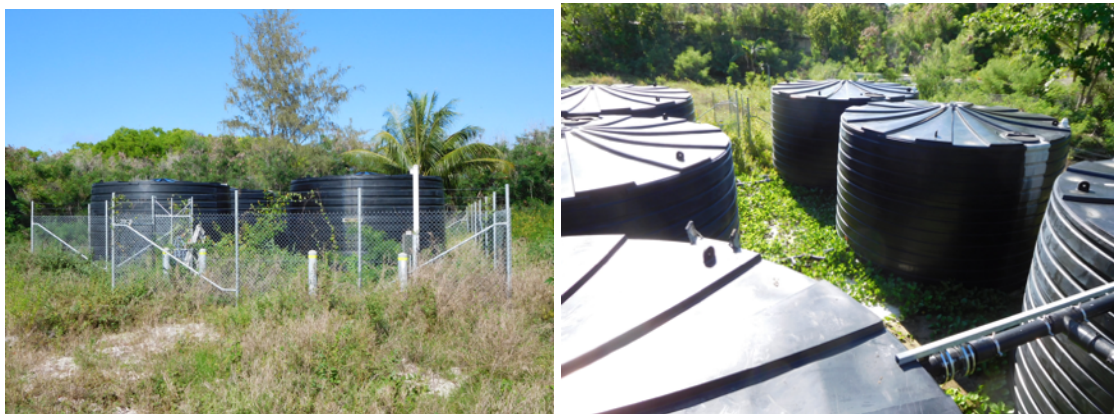
4. A new school building has been constructed and a new Sewage Treatment Plant has been constructed for this new extension.
5. The STP for the new school building is now being used as the discharge location for the island’s septic tank pump outs. At the time of the site visit on 19th May 2017, these tanks were starting to overflow and this STP is similarly not capable of treating all of the island’s sewage.

Figure 20. New Sewage Treatment Plant for New Building at Nauru Primary School

In summary, the 2015 recommendations are still valid that a CED sewerage system with a Municipal Treatment Plant capable of handling the islands sewage should be provided. In addition, minor works should be carried out to bring the sewage treatment plant at Nauru Primary School up to successful operation.

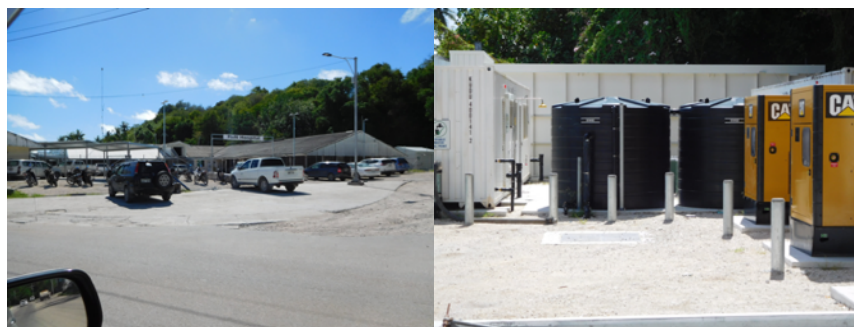
The RON Hospital as part of its recent upgrade works has constructed a new sewage tanks. The RON Hospital has a planned sewage treatment plant under the Hospital planning in 2015 and it was proposed to treat hospital waste separate to domestic sewage. It appears that this has been implemented and will not change the proposed works under the 2015 Master Plan.

Figure 23. RON Hospital with Black Sewage Tanks (Right Hand Side)
