Survey of the Regional Distribution and Status of Asbestos-Contaminated Construction Material and Best Practice Options for its Management in Pacific Island Countries

**Report for the
Republic of Nauru**

**Prepared for the Secretariat of the Pacific Regional
Environment Programme (SPREP)**

June 2015

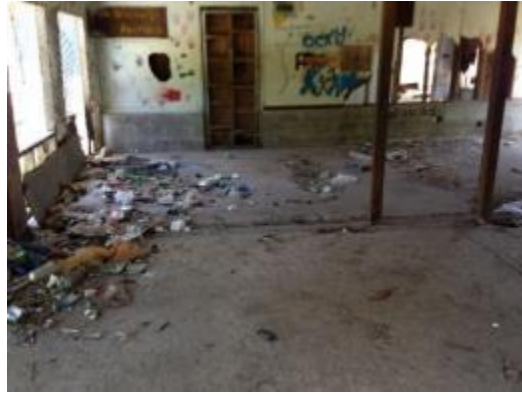
Photo 11 shows a close-up of possible cladding and Photo 12 shows an abandoned house littered with asbestos debris. This abandoned house was close to other houses and children were noted playing in the asbestos debris.

Photo 12 – Asbestos Debris in Old House

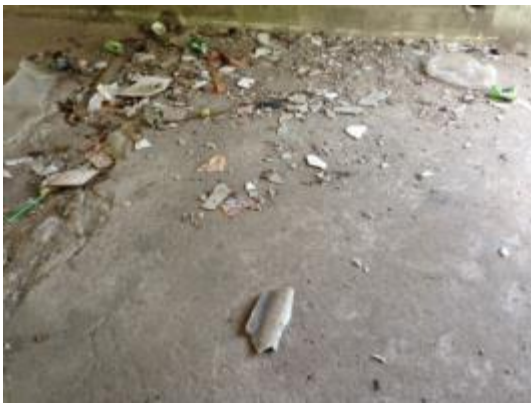
In addition asbestos debris litters sealed and grassed areas around houses, see Photos 13 and 14 below. Such asbestos litter and debris is quite common around houses on Nauru.

Photo 13 – Asbestos Debris around House

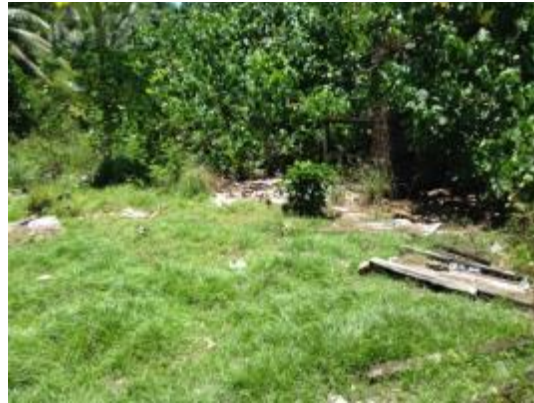
Photo 14 – Asbestos Debris in Back Yard

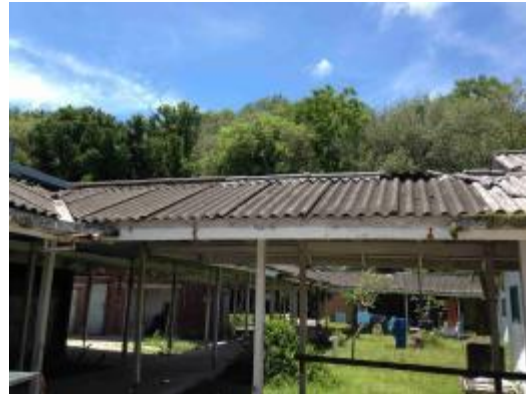
Numerous photos of the RON Hospital are shown in Appendix 8. Three more are shown below, namely part of the old Block and the parapet ceiling. Both the roofing and the parapet ceiling have been confirmed as asbestos – see Section 5 below.

Photo 16 – Hospital Parapet Roof

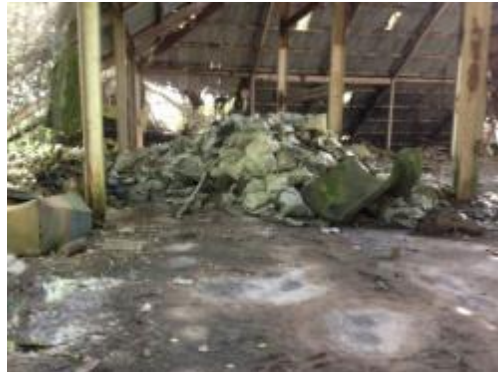
Photo 57 below shows the stockpile of insulating material in 2B storage area near the processing area. This material is also in a nearby storage area and both locations were sampled (three samples from each). All samples demonstrated that the insulating material was fibreglass.

Photo 57- Abandoned Insulating Material

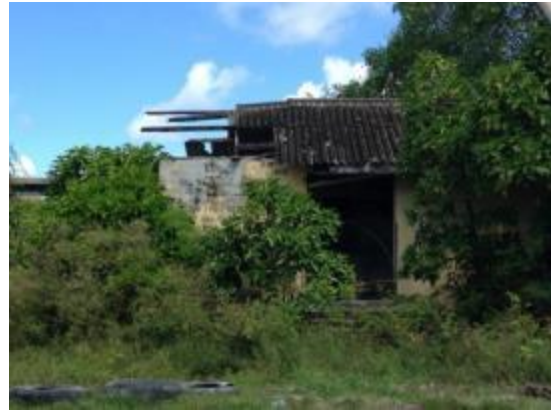
Photo 69 - Derelict Building Aiwo

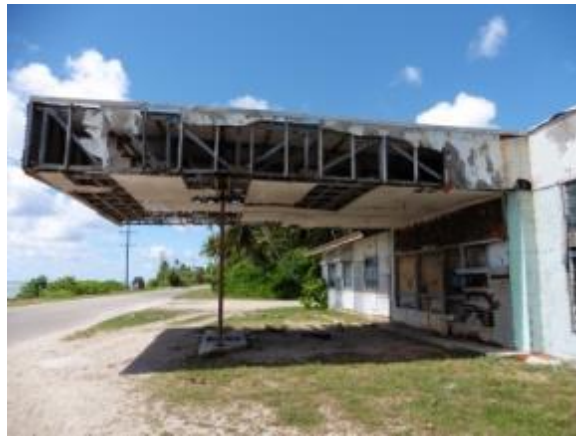
Photo 70 - Abandoned Petrol Station

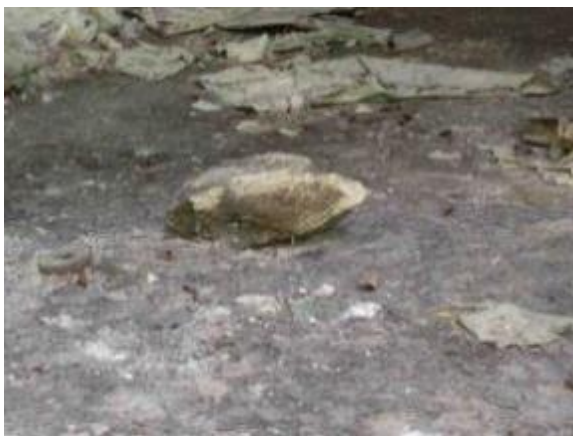
Photo 15 – Lump of Reported Asbestos
