Survey of the Regional Distribution and Status of Asbestos-Contaminated Construction Material and Best Practice Options for its Management in Pacific Island Countries

**Report for the
Republic of Nauru**

**Prepared for the Secretariat of the Pacific Regional
Environment Programme (SPREP)**

June 2015

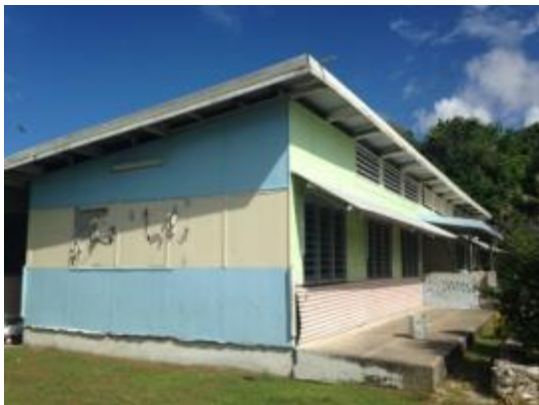
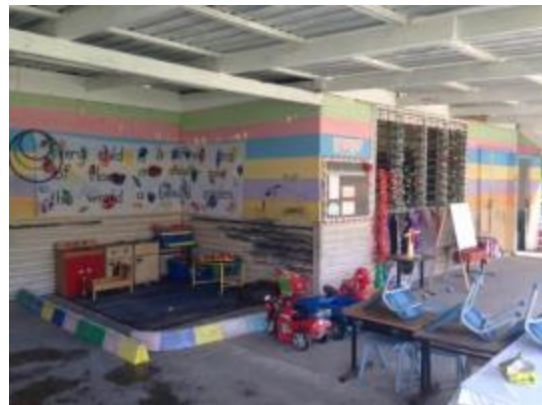
Photos 23-26 – Nibok Infant School Asbestos Cladding and Suspected Ceiling

16/3/12/Bulk	Boe Infant School	Old School - Cladding mid area	EMS / PacWaste	Chrysotile 7%
17/3/12/Bulk	Nauru College	Cladding	EMS / PacWaste	None Detected
1/4/12/Bulk	Kayser College	Old Block Cladding	EMS / PacWaste	None Detected
2/4/12/Bulk	Nibok Infant School	Cladding	EMS / PacWaste	Chrysotile 7%
3/4/12/Bulk	RonPHOS Workshop	Roofing	EMS / PacWaste	Chrysotile 65%
4/4/12/Bulk	Nibok Infant School	Vinyl Floor Tiles	EMS / PacWaste	None Detected
5/4/12/Bulk	Old NPC House (was Bakery)	Cladding	EMS / PacWaste	None Detected
6/4/12/Bulk	RonPHOS Workshop	Cladding	EMS / PacWaste	Chrysotile 5%
	Power Station Building	Gable / Main Eastern Entrance Cladding	GHD Survey 2007	Chrysotile, Amosite, Crocidolite
	Power Station Building	Edge of Roof, Northern Side	GHD Survey 2007	Chrysotile
	Power Station Building	West Wall, Northern End	GHD Survey 2007	Chrysotile
	Power Station Building	Wall Entrance to Switchboard Corridor, (North Side)	GHD Survey 2007	Chrysotile

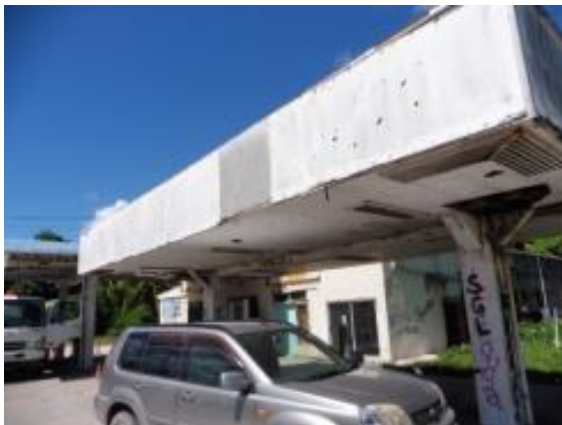
Photo 66 - Chinese Restaurant/Petrol Station

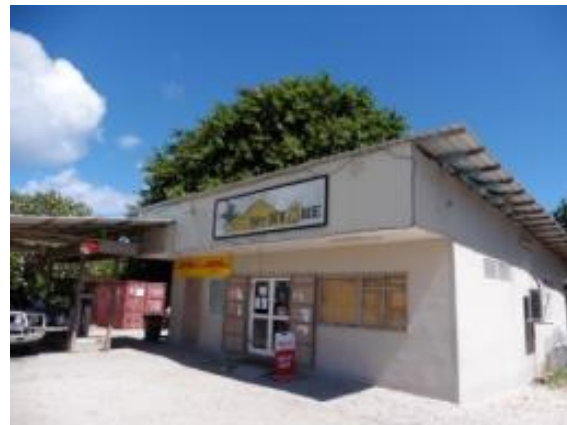
Photo 67 - My Store / DHL

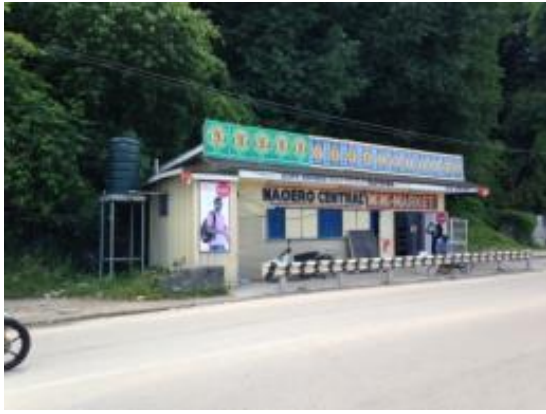
Photo 68 - Naoero Central Store

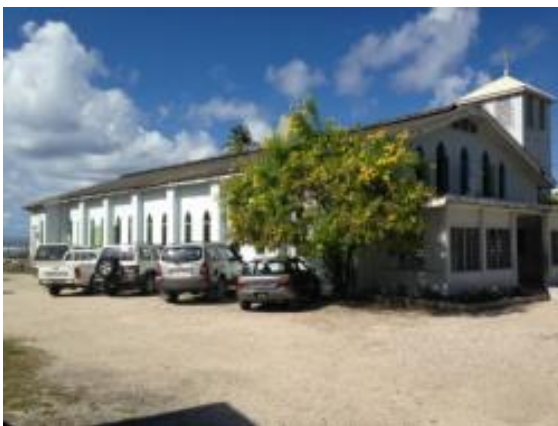
Photo 71 - Catholic Church

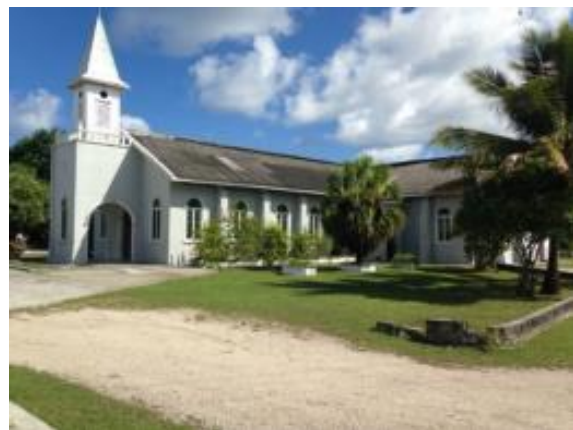
Photo 72 - Orro Church

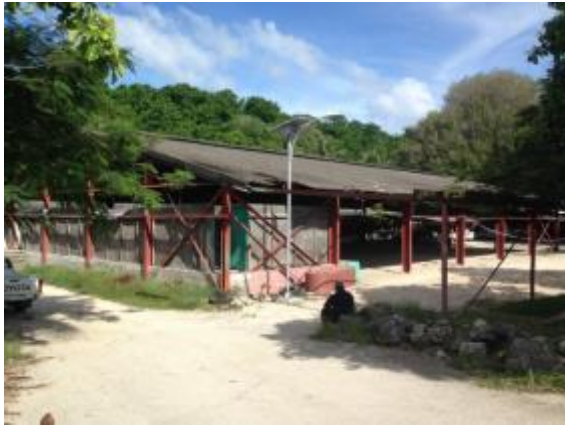
Photo 73 - Nauru Independent Church

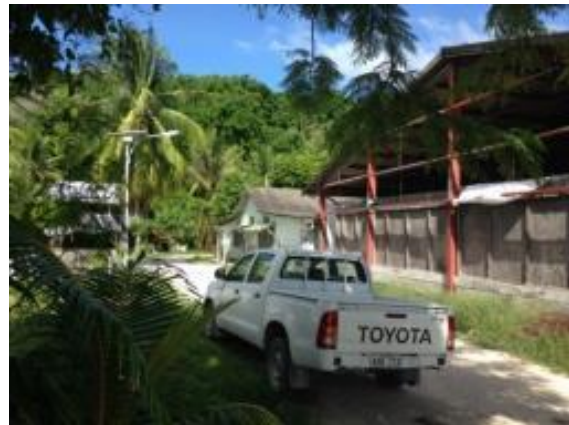
Photo 74 - Nauru Independent Church House

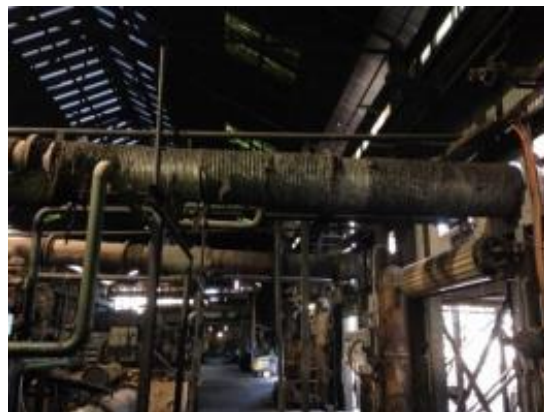
There was rope insulation on the exhaust from one of the generators and it was suspected of being asbestos. Subsequent testing has established that this is fibreglass – see below.

Photo 81 – Fibreglass Rope Lagging

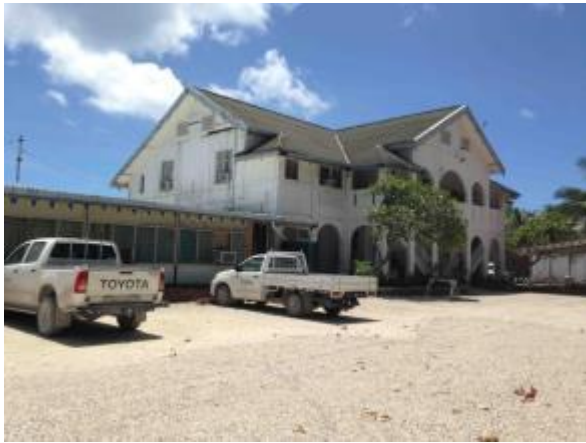
Photo 1 – PONPhos Head Office

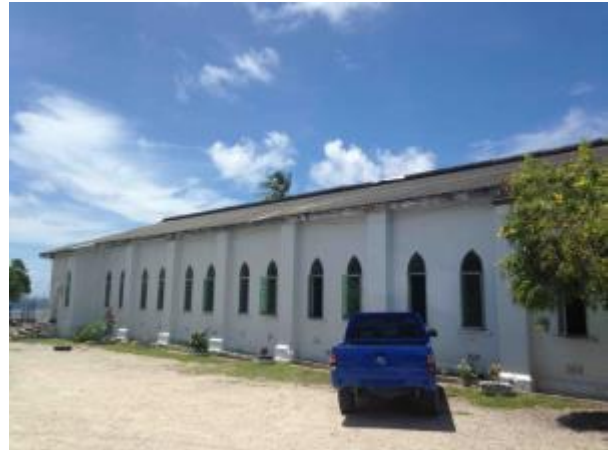
Photo 2 – Catholic Church

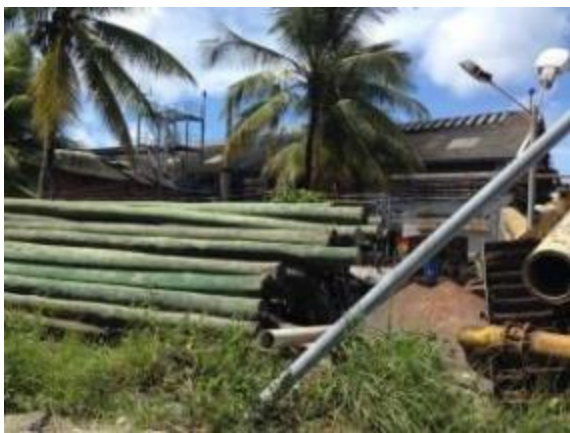
Photo 3 – Power Station

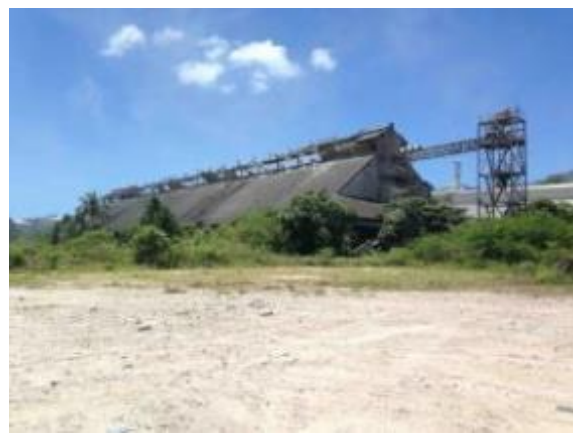
Photo 4 - Old Phosphate Store

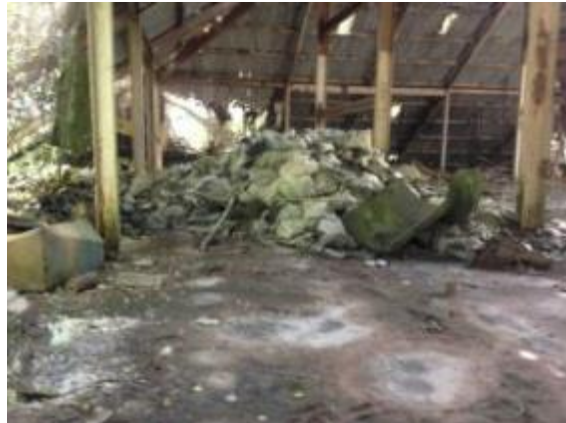
We all went to inspect this stockpile of reported pure asbestos and found it to be a potentially serious issue. There was a large pile of bags in a building in very poor condition (see Photos 13-15 below). We were also advised that there was a nearby tunnel that contained an even large number of such bags (see Photo 16 below). Possibly around 100 tonnes is stored there.

Photo 14 – Another View of the Bags

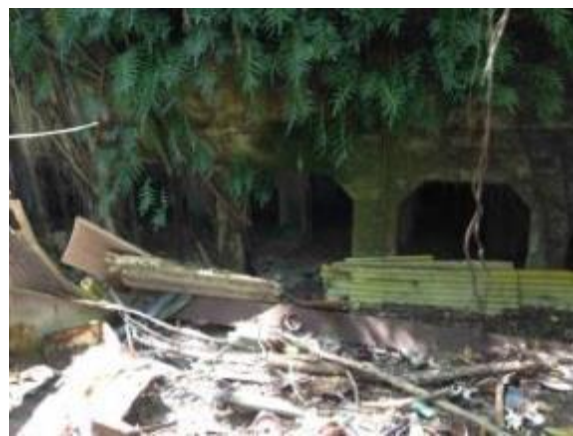
Photo 16 – Tunnel Reported to Contain More Bags
